Data quality overview

This report describes issues that should be considered when further processing any of the 2009 ARSF datasets. The document will be updated over the course of the year, with the latest version available at:

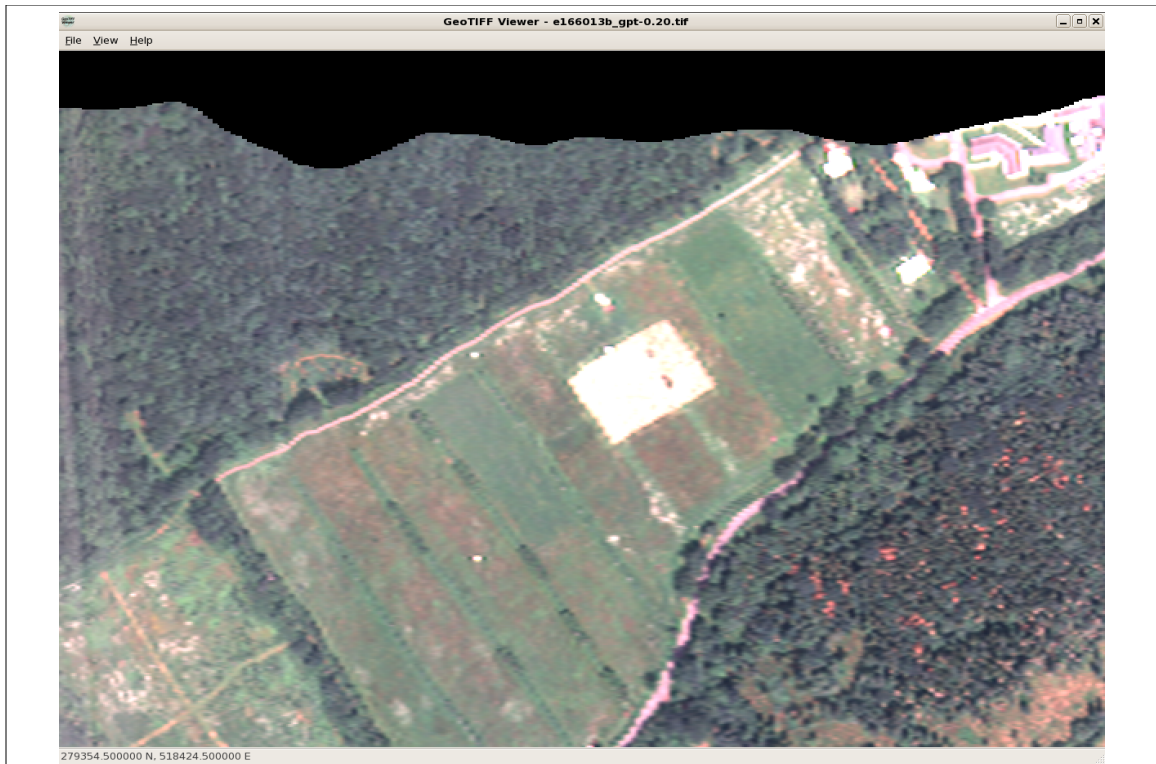
Correction of the timing offsets between navigation and imagery has been necessary to correct errors in some flight lines. Timing errors cause scan lines to be positioned incorrectly and manifest visually as "wobbles" in the imagery correlated to but out of sync with movements of the aircraft. An example is shown in Figure 1 below.

Figure 1a: timing error in an Eagle line

We endeavour to correct all timing errors prior to delivery. As this is a manual process and relies on finding suitable visible features in the imagery, some errors may still remain. If any are found, please contact us at arsf-processing@pml.ac.uk.

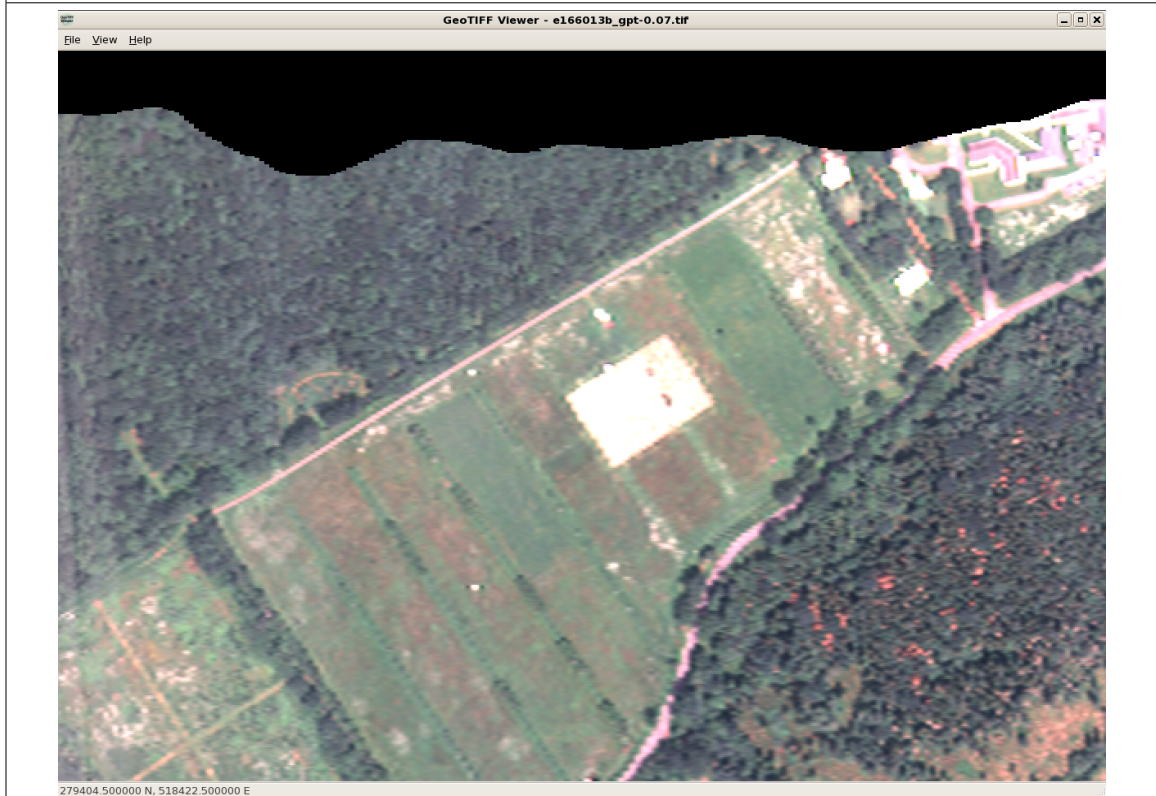
Figure 1b: corrected version of above (0.13 seconds difference)

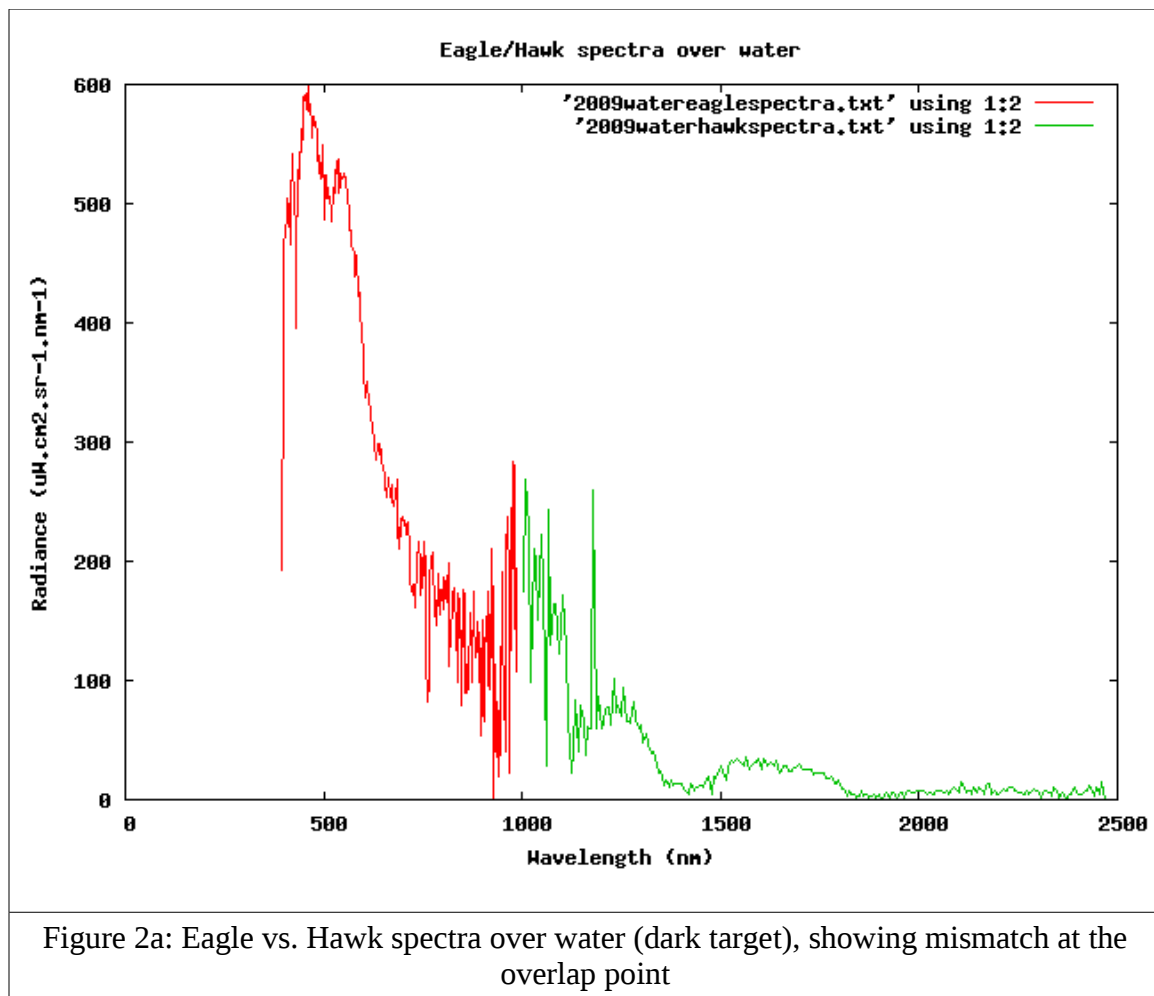
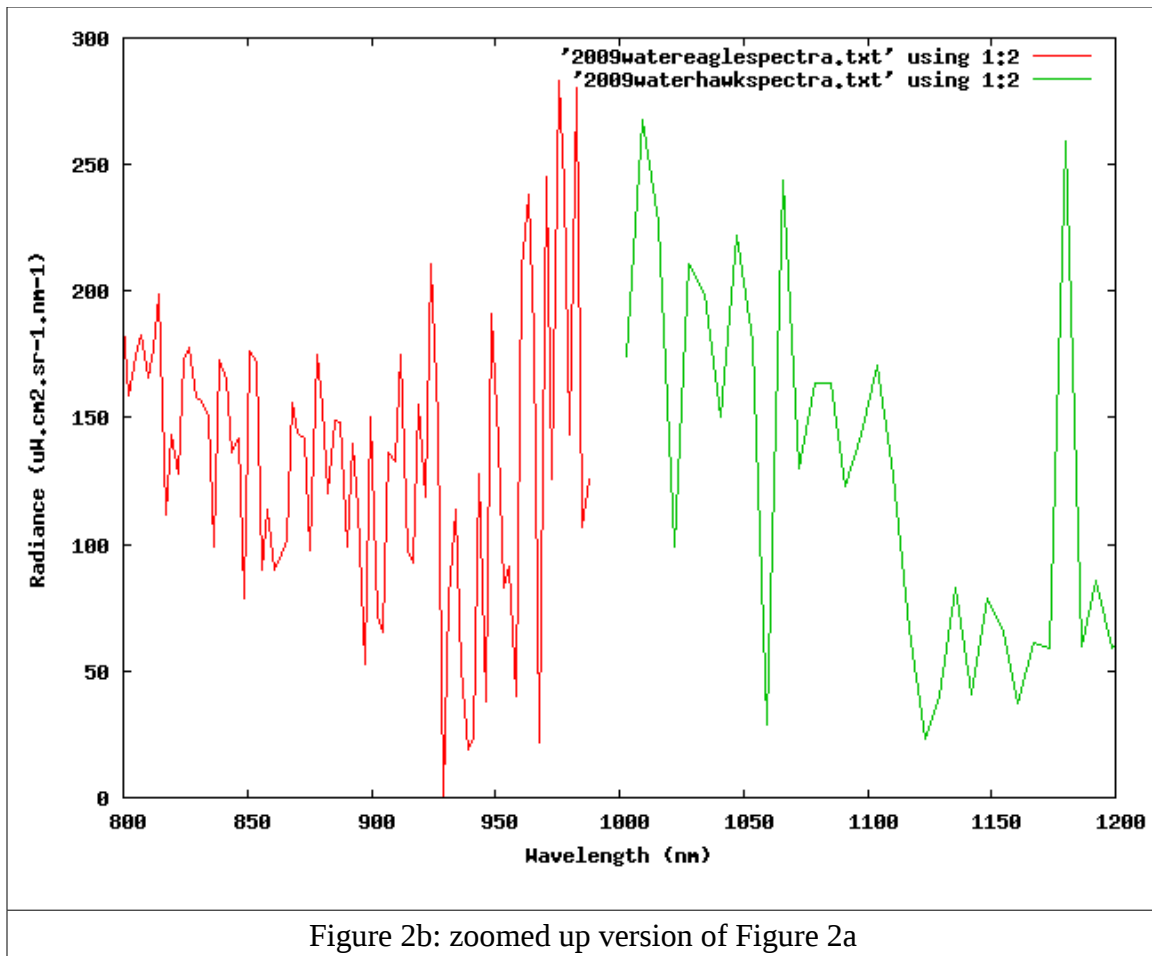
The data quality appears to degrade at the low and high wavelength limits of both Eagle and Hawk. For example, a comparison of pixels near the high Eagle wavelengths and low Hawk wavelengths, over dark targets such as water reveals a mismatch (see Figure 2). Caution is advised when examining spectral responses at the edges of the usable range.

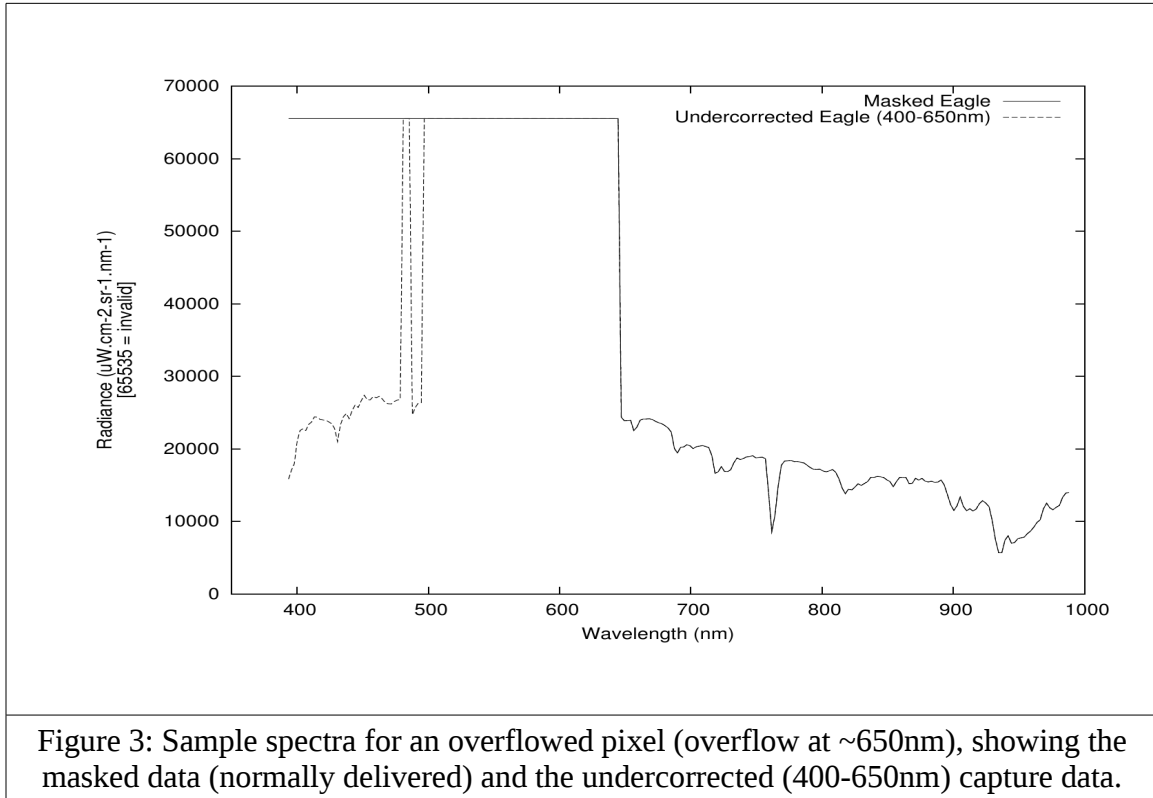
In Hawk, overflows are marked for just the pixel/band in question. However, Eagle uses a frame transfer CCD, where data are read out in rows. Incoming light continues to accumulate in unread rows during the transfer and is removed by “smear correction” software, which relies on data from one row to correct the next. If a pixel overflows, information is lost and all subsequent pixels in that column cannot be fully corrected. In Eagle, the net effect is that an overflow at 600nm will cause all bluer bands (600nm -> ~400nm) to be undercorrected for that spatial pixel.

When Eagle data with overflows are delivered, we mark as bad all bands following an overflow as they will incorporate some unknown additional light. If your Eagle data contains overflows, the spectrum for that pixel will look like the masked Eagle (solid line) in Figure 3. The dashed line in Figure 3 shows what data were captured, although some are undercorrected – if you wish your data delivered unmasked, please contact us.

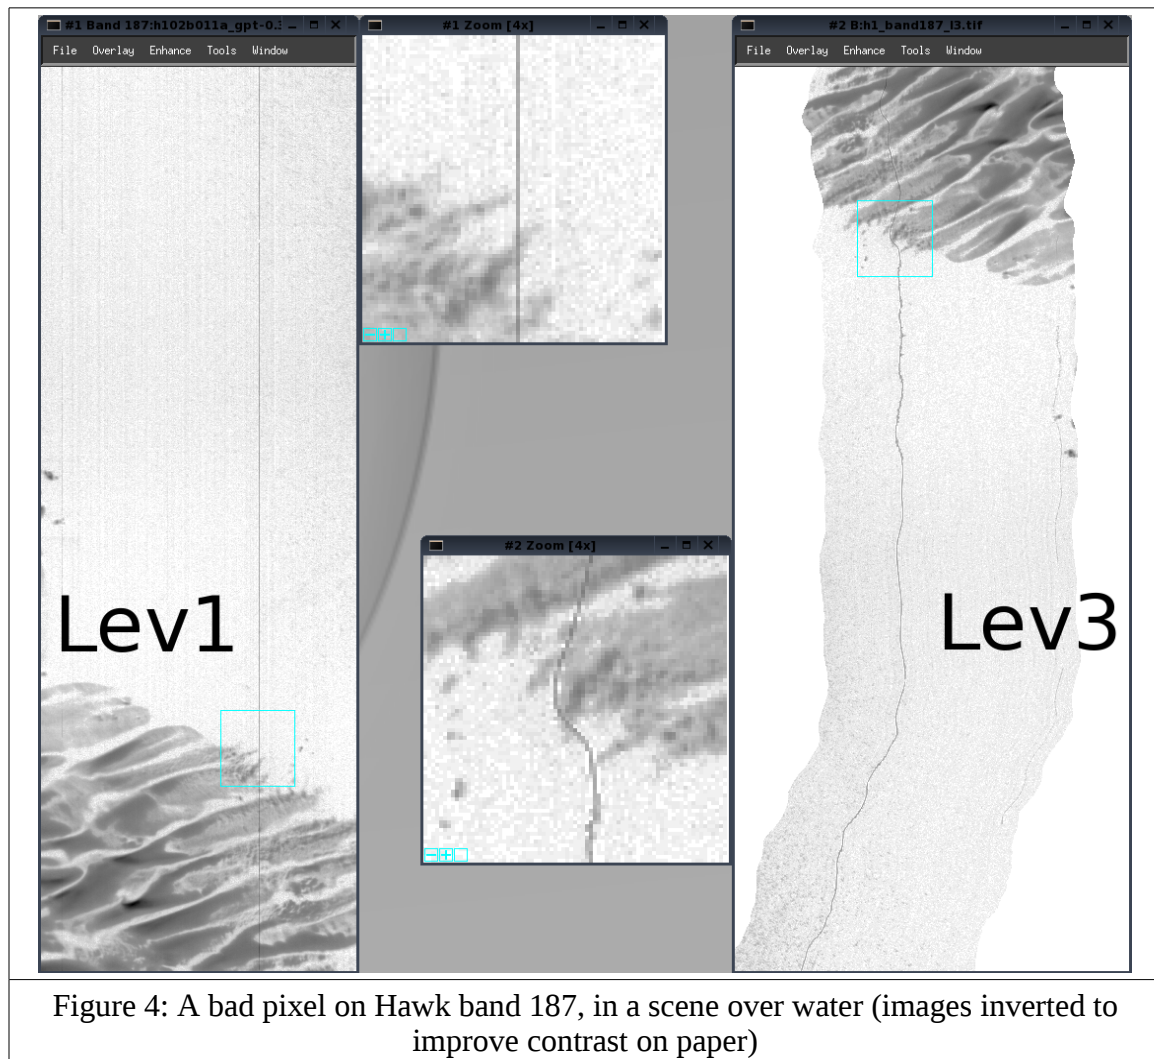
While the majority of bad pixels are corrected or blanked out, some have not been detected and may appear in delivered data. These appear in level 1 datasets as straight lines along the direction of flight and as undulating lines in level 3 following the motion of the aircraft (e.g. Figure 4). Typically, they will only affect a single band and are difficult to detect. A complete solution for detecting and removing these will be pursued in 2008.

Figure 4: A bad pixel on Hawk band 187, in a scene over water (images inverted to improve contrast on paper)
