## Data quality overview

This report describes issues that should be considered when further processing any of the 2009 ARSF datasets. The document will be updated over the course of the year, with the latest version available at:

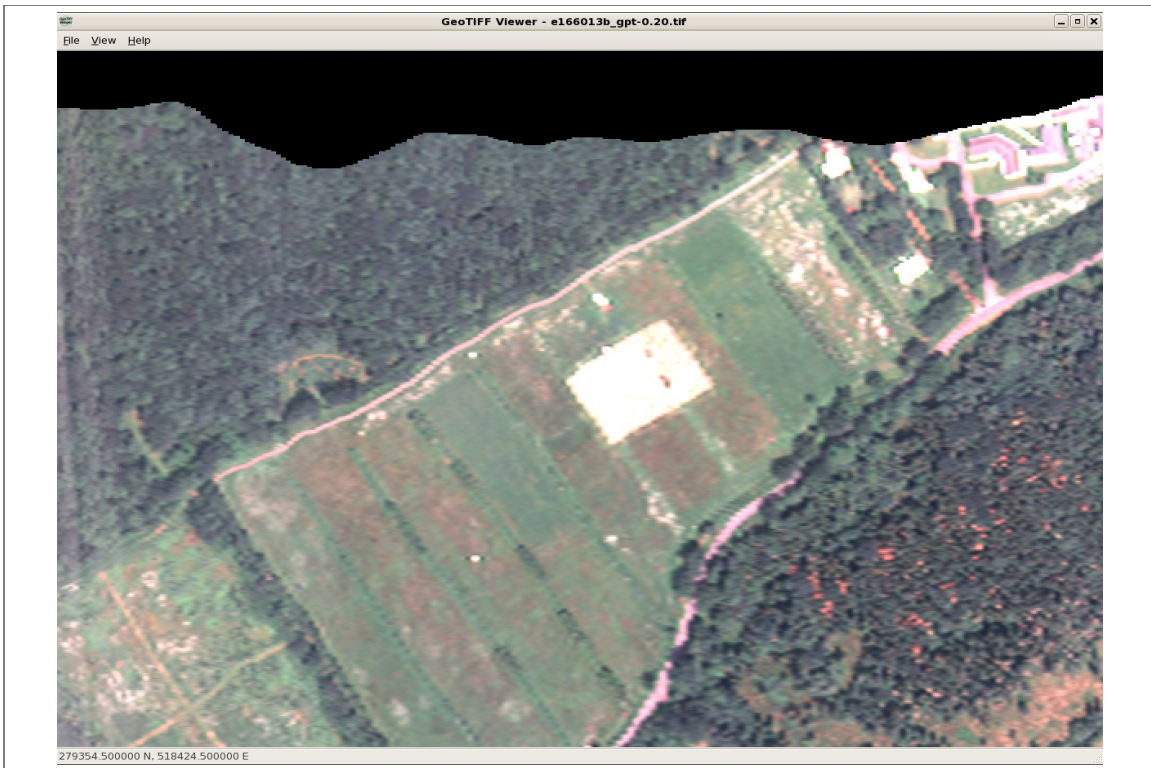
Correction of the timing offsets between navigation and imagery has been necessary to correct errors in some flight lines. Timing errors cause scan lines to be positioned incorrectly and manifest visually as "wobbles" in the imagery correlated to but out of sync with movements of the aircraft. An example is shown in Figure 1 below.

Figure 1a: timing error in an Eagle line

We endeavour to correct all timing errors prior to delivery. As this is a manual process and relies on finding suitable visible features in the imagery, some errors may still remain. If any are found, please contact us at [arsf-processing@pml.ac.uk](mailto:arsf-processing@pml.ac.uk).

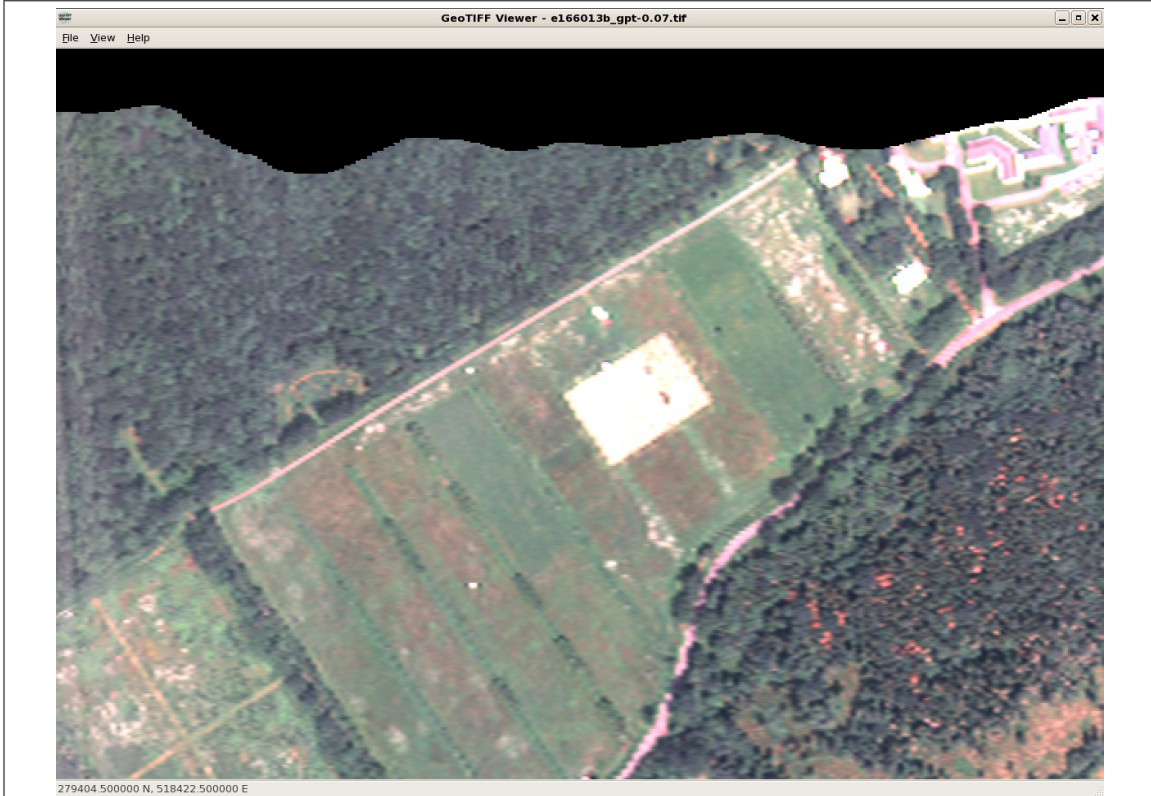
Figure 1b: corrected version of above (0.13 seconds difference)

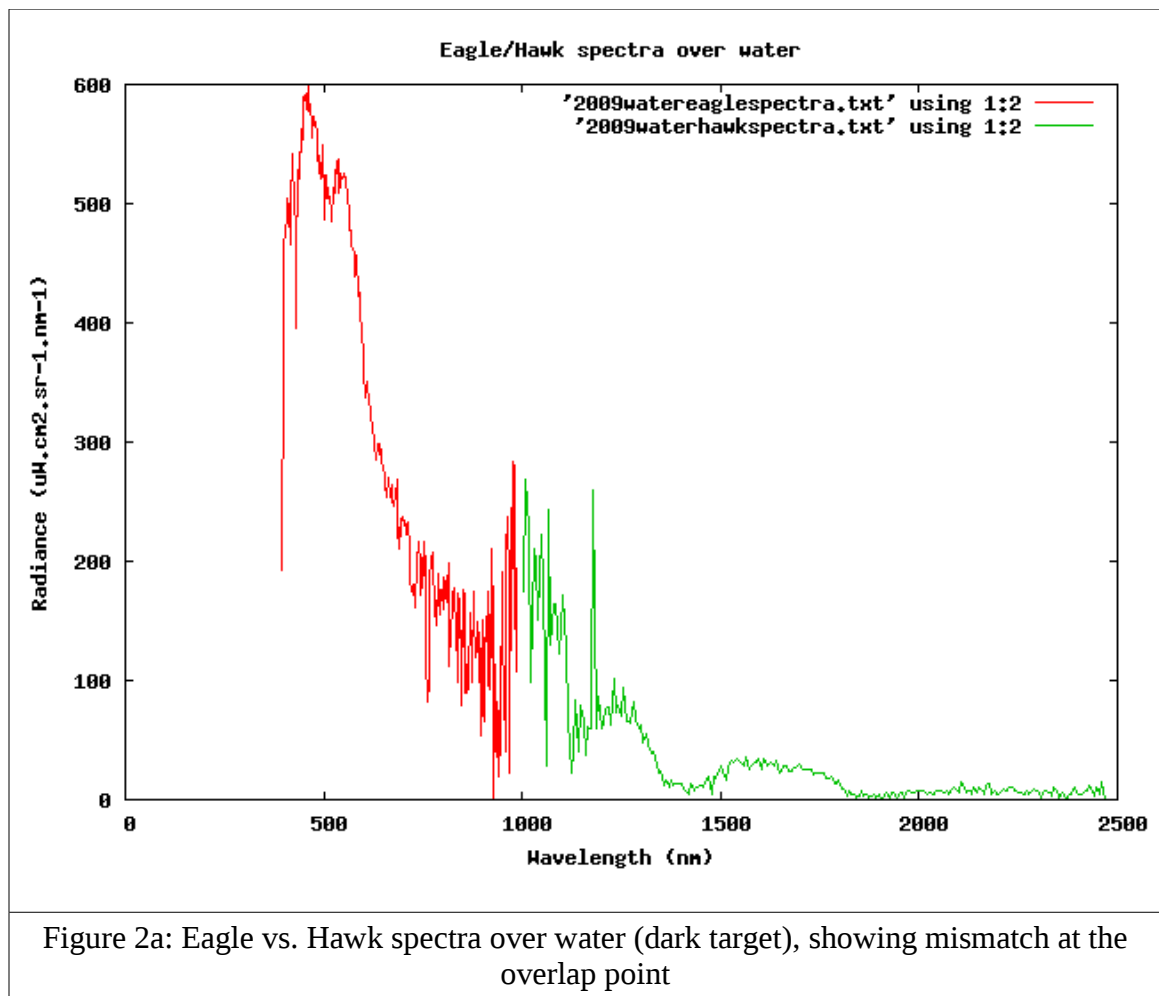
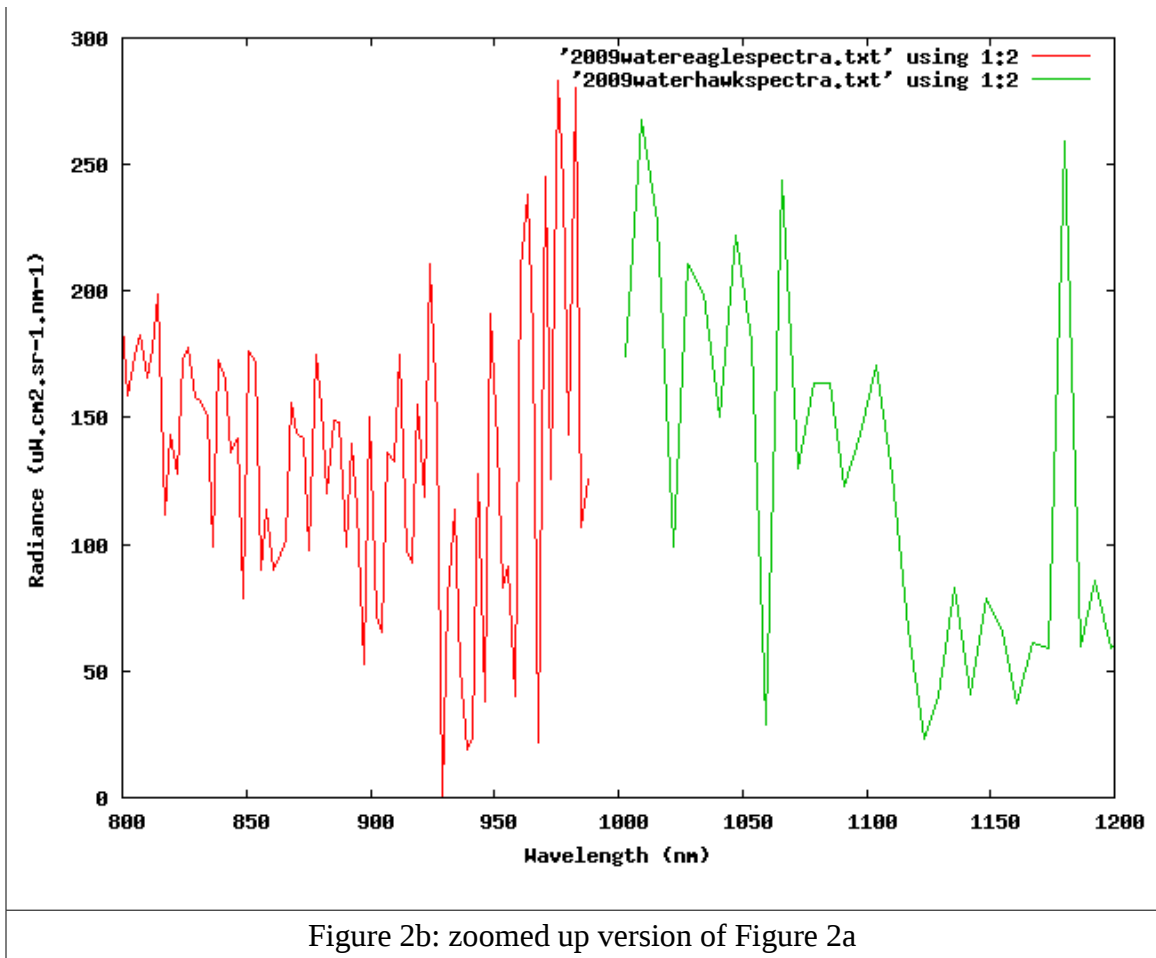
The data quality appears to degrade at the low and high wavelength limits of both Eagle and Hawk. For example, a comparison of pixels near the high Eagle wavelengths and low Hawk wavelengths, over dark targets such as water reveals a mismatch (see Figure 2). Caution is advised when examining spectral responses at the edges of the usable range.

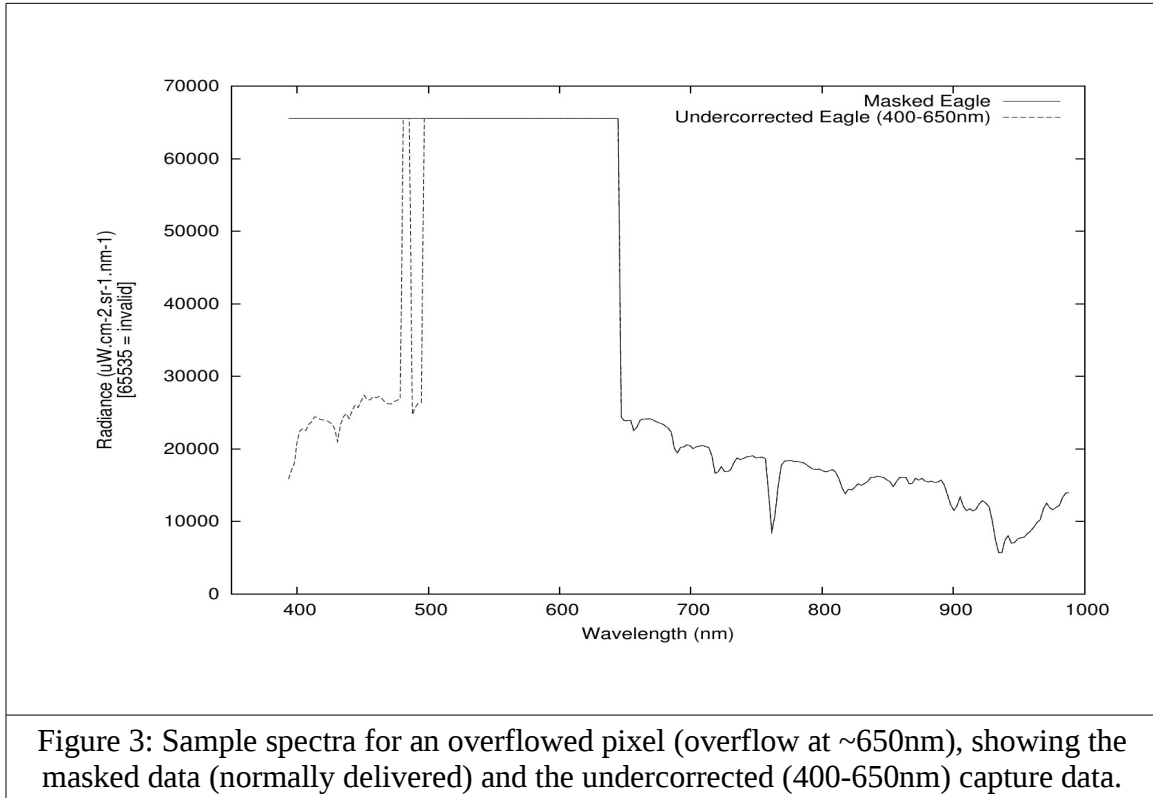
In Hawk, overflows are marked for just the pixel/band in question. However, Eagle uses a frame transfer CCD, where data are read out in rows. Incoming light continues to accumulate in unread rows during the transfer and is removed by “smear correction” software, which relies on data from one row to correct the next. If a pixel overflows, information is lost and all subsequent pixels in that column cannot be fully corrected. In Eagle, the net effect is that an overflow at 600nm will cause all bluer bands (600nm -> ~400nm) to be undercorrected for that spatial pixel.

When Eagle data with overflows are delivered, we mark as bad all bands following an overflow as they will incorporate some unknown additional light. If your Eagle data contains overflows, the spectrum for that pixel will look like the masked Eagle (solid line) in Figure 3. The dashed line in Figure 3 shows what data were captured, although some are undercorrected – if you wish your data delivered unmasked, please contact us.

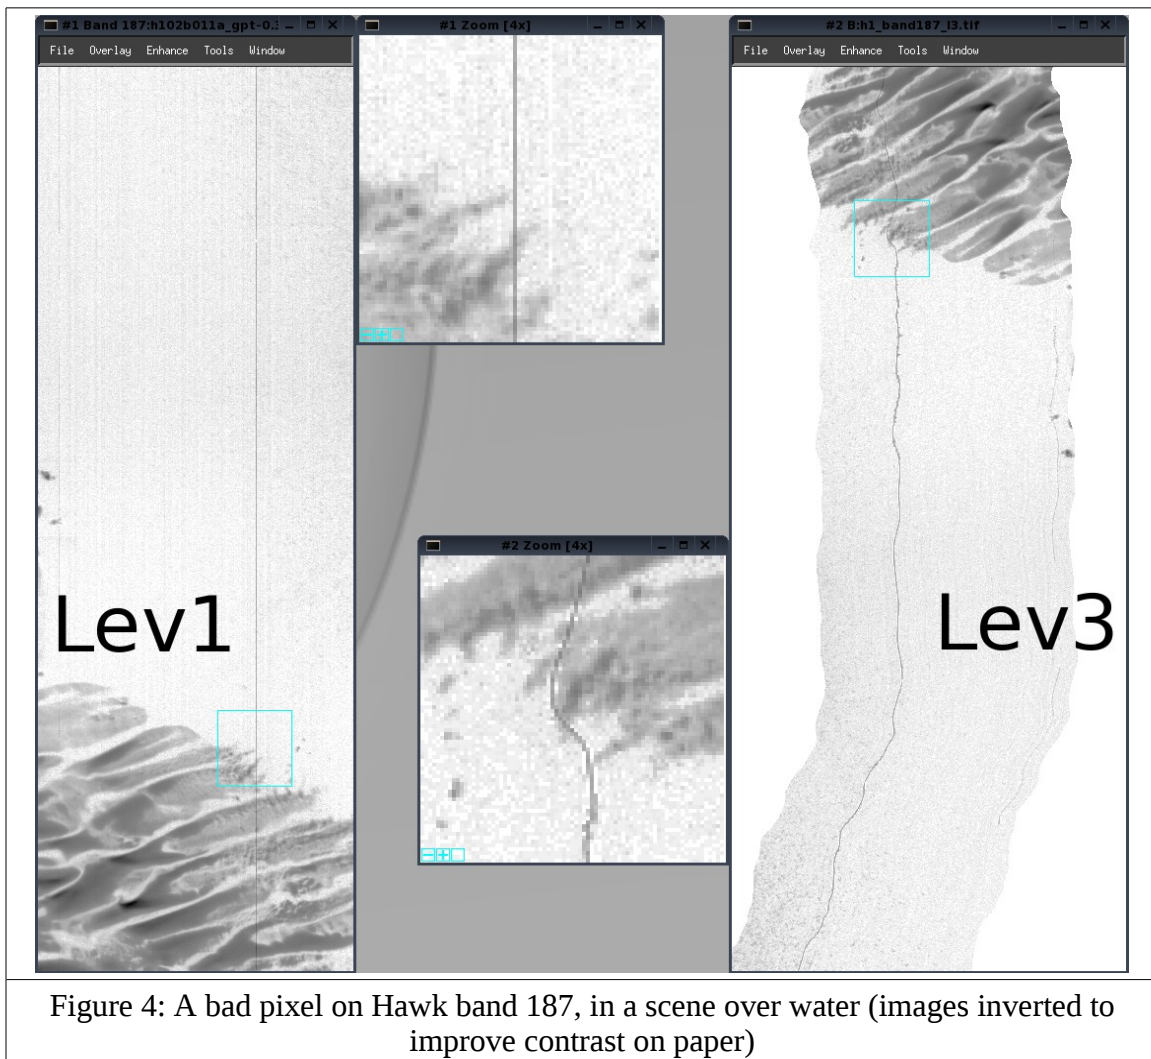
The Hawk instrument has a number of bad pixels that give inaccurate values. There are different types of error (e.g. constant pixel values, uncorrected offset, duplicating neighbouring pixels, etc), and ~1% of bad pixels are to be expected on the type of CCD used in the Hawk instrument. Specim has provided a list of known bad pixels and these are filled with zero values in delivered data.

While the majority of bad pixels are corrected or blanked out, some have not been detected and may appear in delivered data. These appear in level 1 datasets as straight lines along the direction of flight and as undulating lines in level 3 following the motion of the aircraft (e.g. Figure 4). Typically, they will only affect a single band and are difficult to detect. A complete solution for detecting and removing these will be pursued in 2008.

Figure 4: A bad pixel on Hawk band 187, in a scene over water (images inverted to improve contrast on paper)

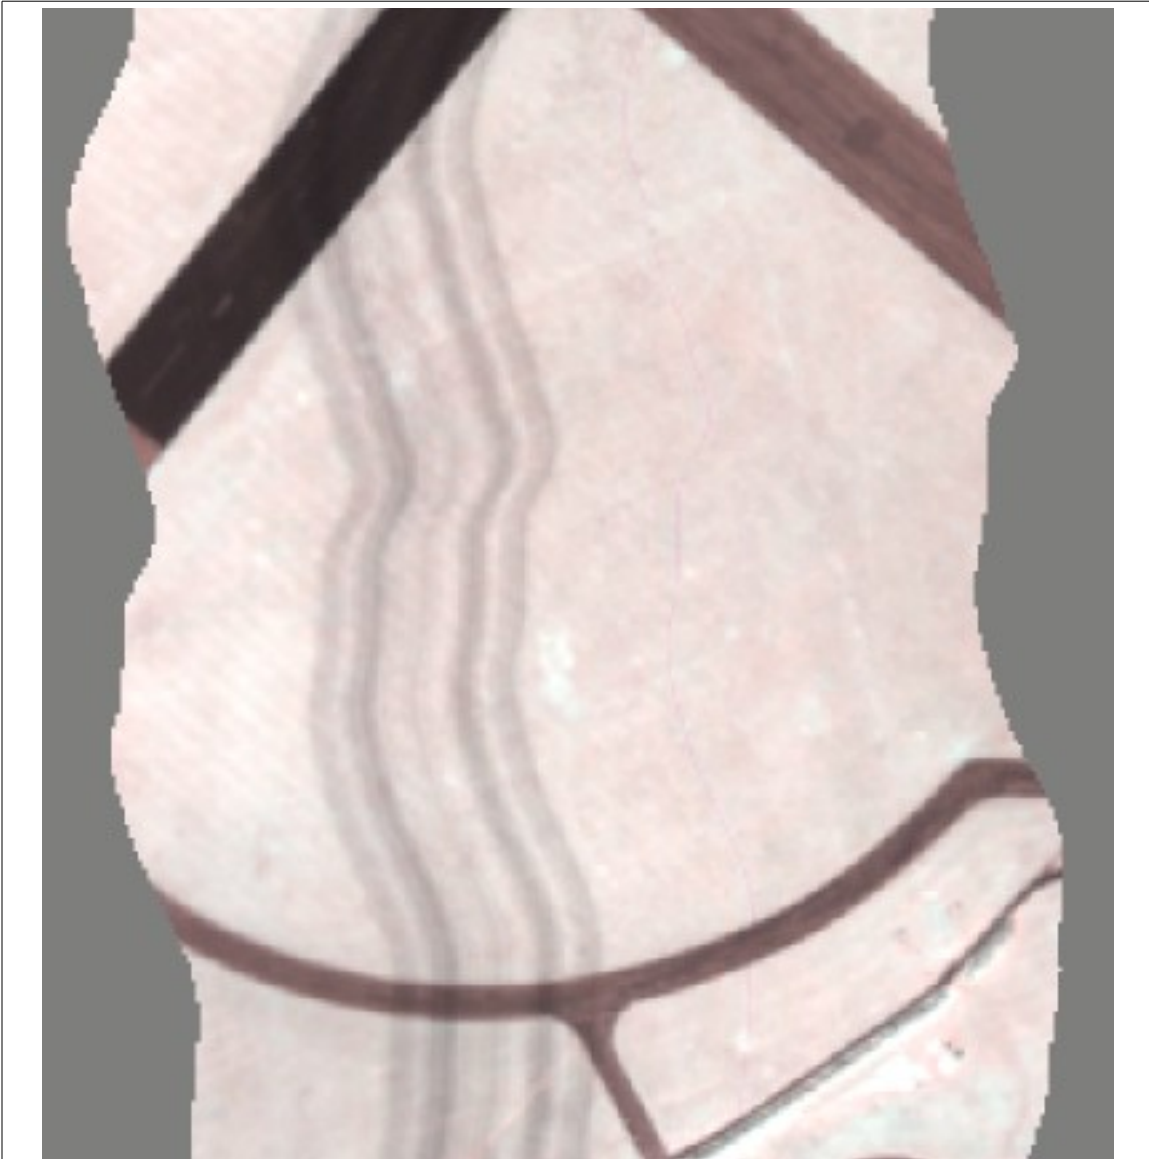
Flights during 2009 up until the end of July contain visible dark stripes in the Hawk data. This is worse from May onwards. This was due to dust getting into the sensor's internal optics. The values obtained from the sensor are lower in the affected areas of the image. The sensor was repaired at the end of July 2009.

Figure 5: Hawk image showing dark stripes
